Valencia College West Campus Technical Memorandum

April 27, 2023

CITY OF
ORLANDO

SOUTHWEST BIKE AND PEDESTRIAN STUDY

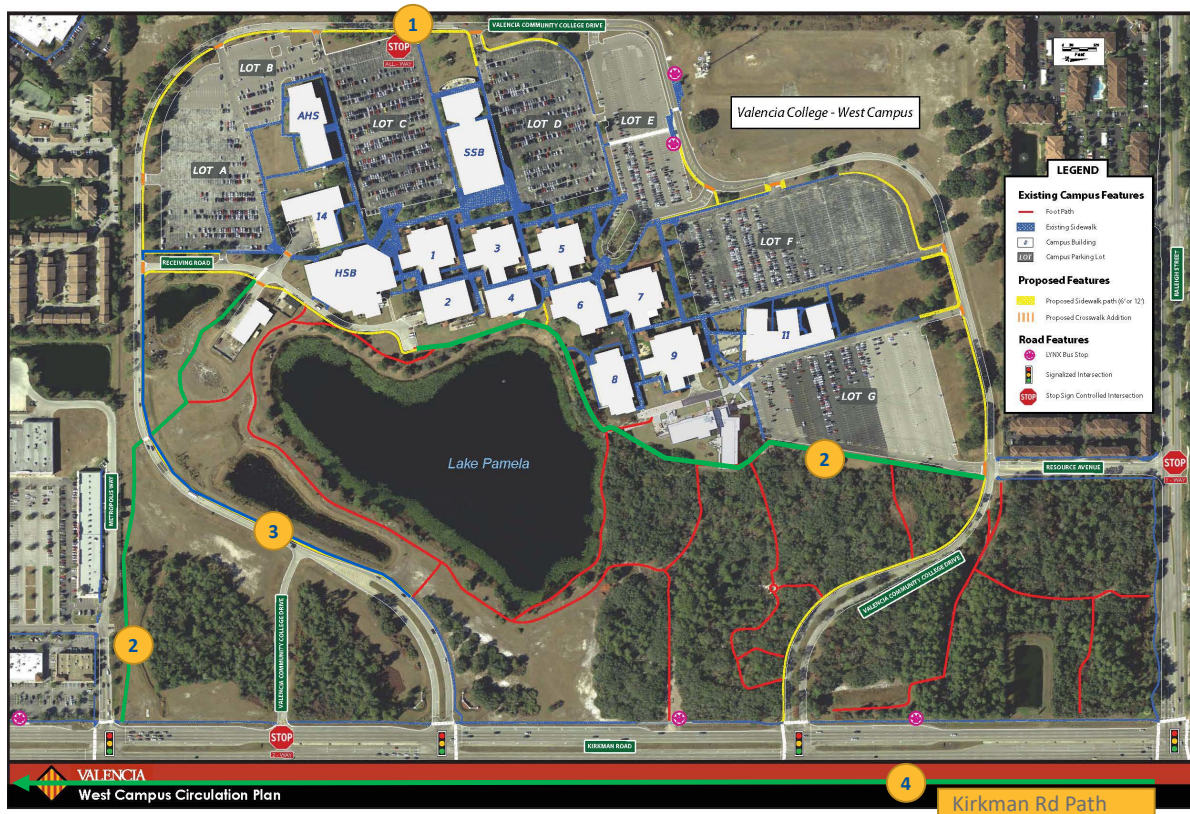
Figure 2 | Valencia College - West Campus Circulation Plan

The Valencia College – West Campus Circulation Plan highlights proposed improvements to enhance the pedestrian/bicycle network within campus. **Figure 2** shows the Circulation Plan as well recently completed improvements such as the roundabout at Valencia College Drive and Metrocenter Boulevard, the newly paved campus multi-use trail connecting to Kirkman Road at Metropolis Way, new sidewalk on Valencia College Drive, and the new path along Kirkman Road.

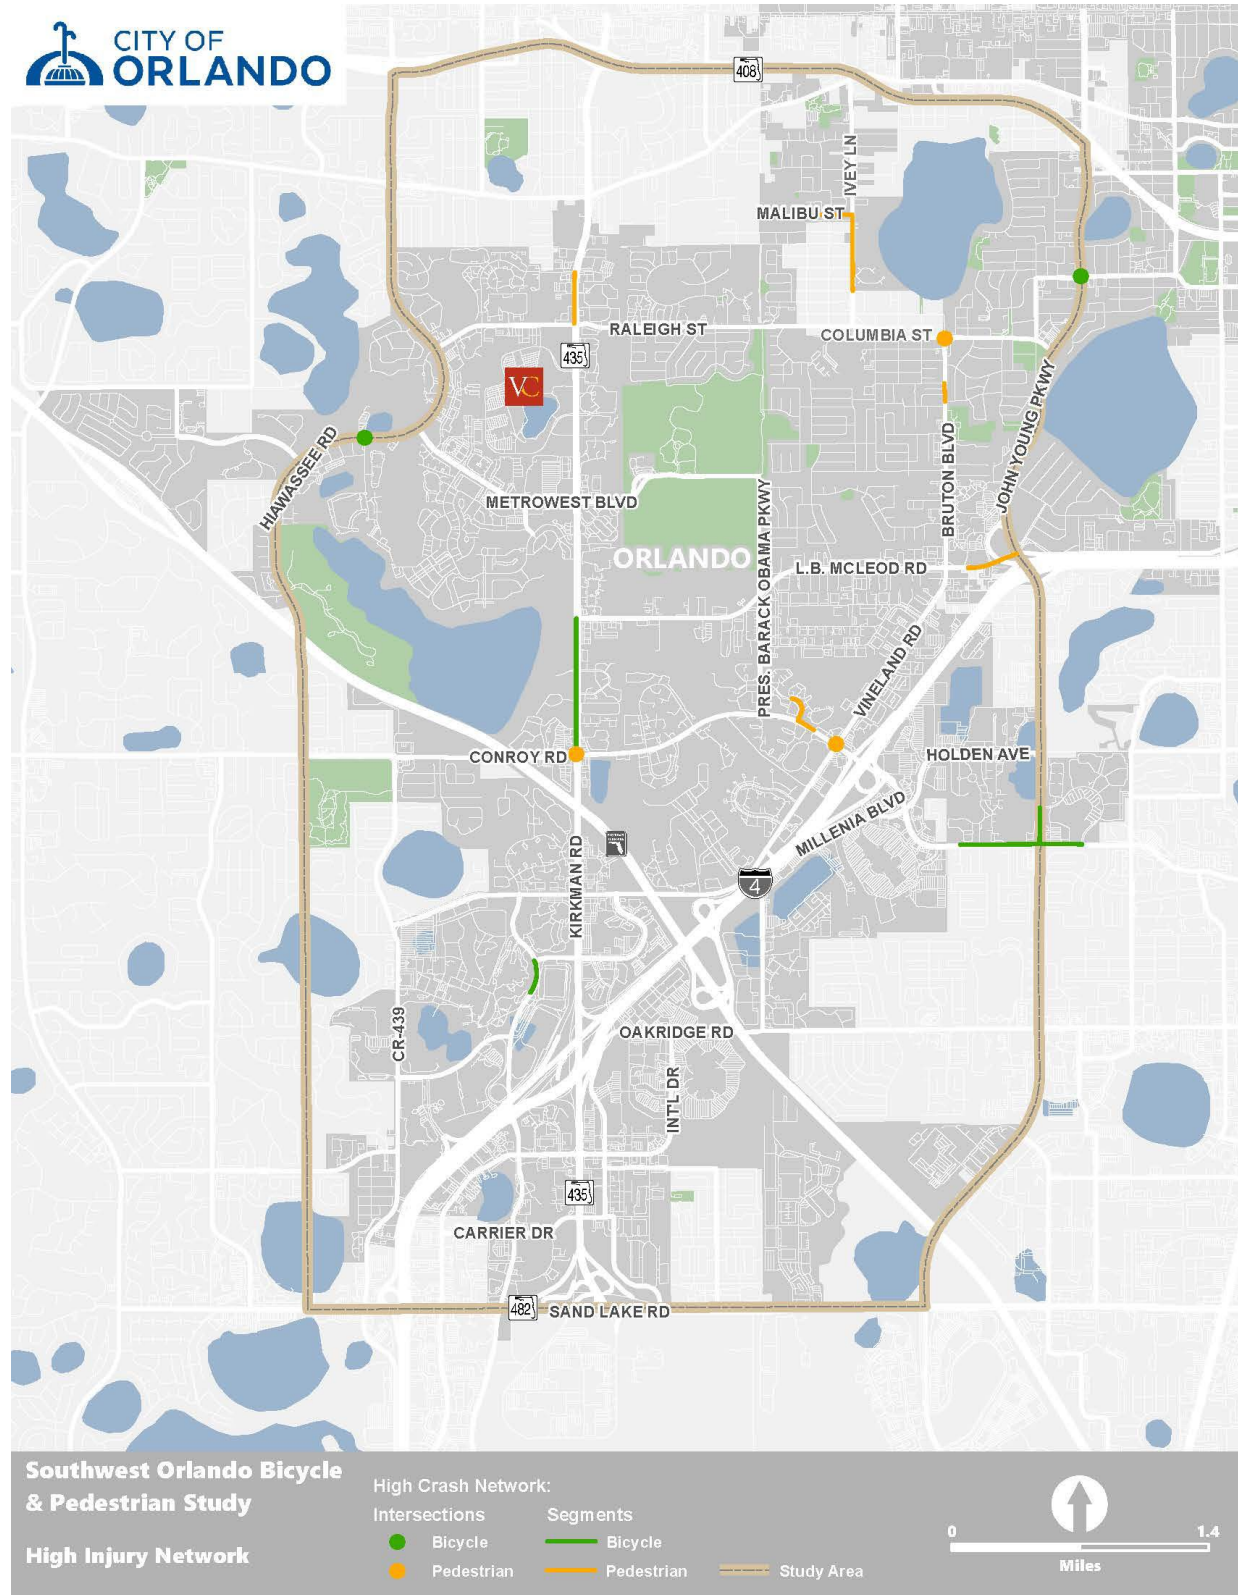
Figure 4 | High Injury Network

A map of the HIN specifically related to bicycle and pedestrian crashes is presented in **Figure 4**. No areas of the West Campus are included in the HIN, but there are nearby locations along the major roadways used to access campus, including segments of Kirkman Road from Raleigh Street to Westgate Drive and from Conroy Road to LB McLeod Road, as well as the intersection of Kirkman Road at Conroy Road, and Hiawasse Road at Lake Debra Drive.

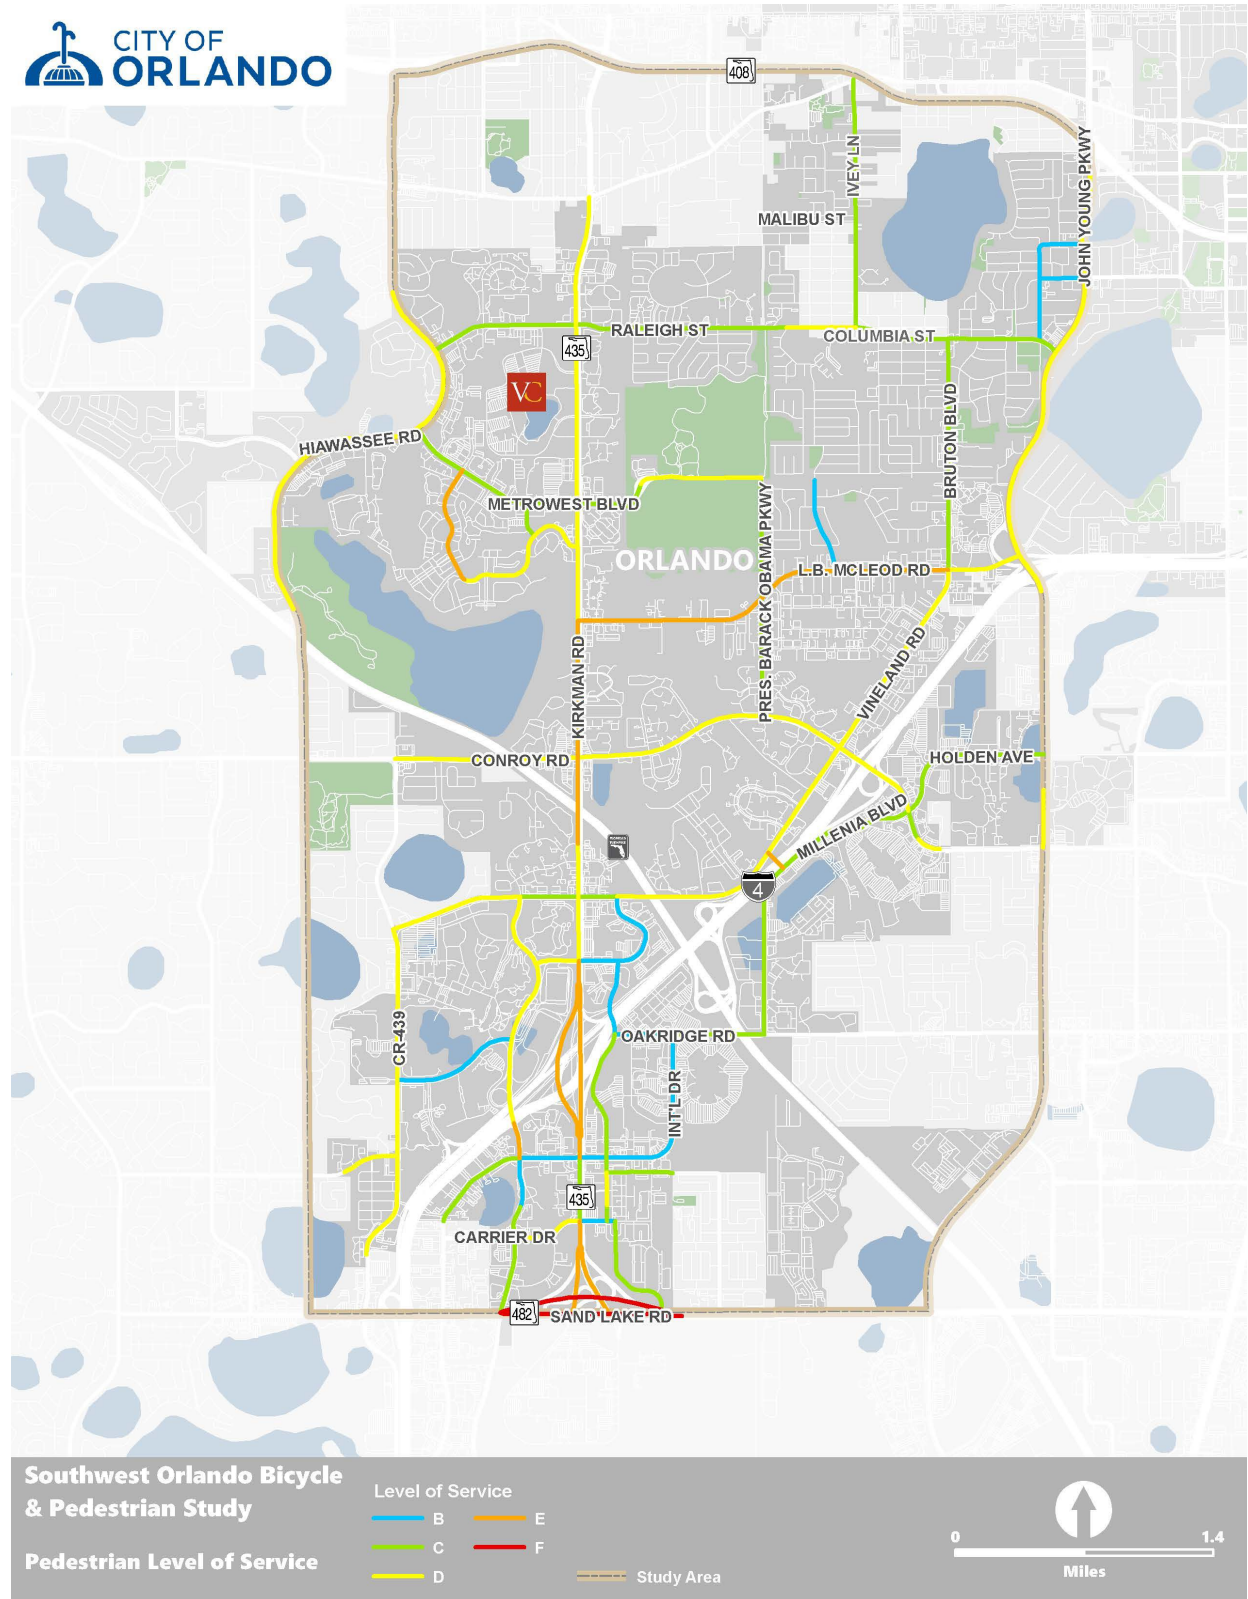
Figure 7 | Pedestrian Level of Service Map

An areawide PLOS analysis was completed for arterial and collector roadways within the southwest Orlando study area. The results indicate a distance-weighted average PLOS score of 3.47 translating to a grade of C for the study network, which compares favorably to other Florida metropolitan areas. Walking conditions in southwest Orlando are aided by the presence of a robust sidewalk network, with sidewalks provided on 87 percent of the arterial and collector system. However, there are still a high number of segments with poor PLOS scores due to a combination of heavy traffic volumes, high speeds, and close proximity of the sidewalk to vehicular traffic. The number of locations with poor scores indicates significant opportunities for improvement. With traffic volumes unlikely to decline, the greatest opportunity to improve walking conditions will be through filling remaining sidewalk gaps and providing additional separation from traffic through wider sidewalks and buffer areas.

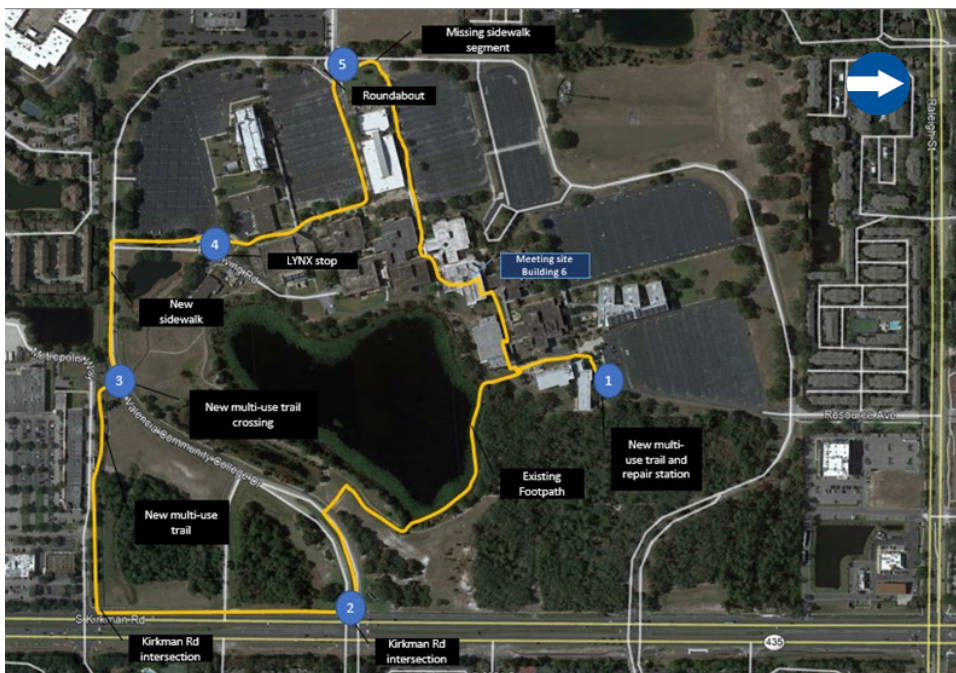
Figure 9 | Walking Audit Route

The purpose of the walking audit/workshop was to assess the conditions for the bike and pedestrian environment within the Valencia College West Campus and main access points to the campus area. Participants also discussed potential improvements that would result in a safer and better-connected campus for walkers and bikers. On Wednesday, November 10, 2021, a total of 14 attendees participated in different portions of the walking audit/workshop, including representatives from the City of Orlando and Valencia College faculty, students, security, and leadership to ensure well-rounded feedback and input on potential solutions. The walking audit targeted one of the busiest days for student activity for the Valencia College West Campus; however, general student and campus activity, including vehicular and pedestrian/bicyclist traffic, were considerably less busy compared to pre-pandemic conditions. The walking audit route included five key locations around campus and the pathways and connections between them, as shown in **Figure 9**. A full summary of the walking audit and workshop is included in the Appendix.

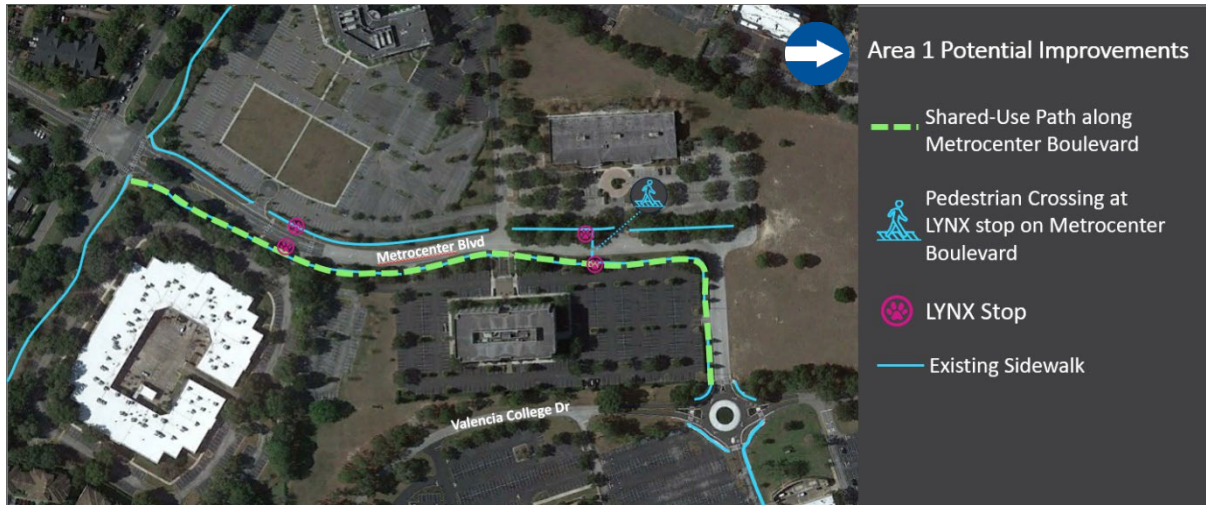
Figure 11 | Area 1 Potential Improvements

Area 1 focuses on improvements for pedestrian/bicycle access to campus from Metrocenter Boulevard, as shown in **Figure 11**. Potential treatments include:

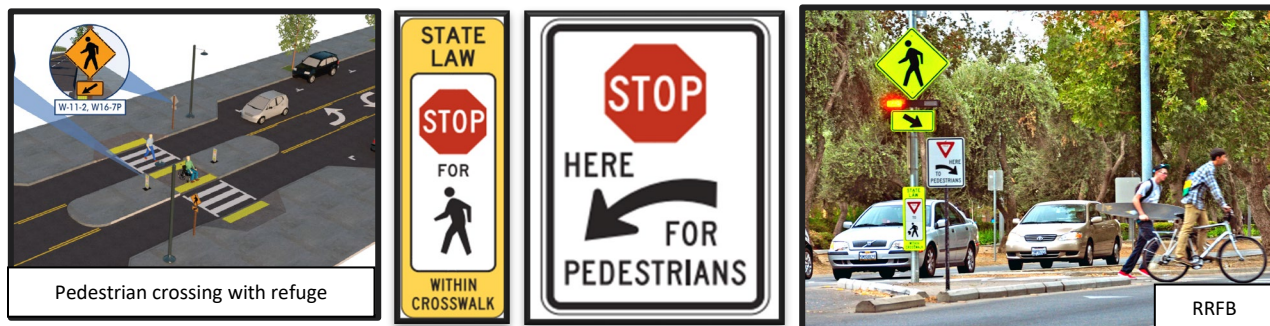
Figure 14 | Multi-Use Trail and Valencia College Drive Crossing Treatment Examples

Examples of these treatment options can be seen in **Figure 14**.

- Replace existing signage with standard pedestrian crossing signage
- Add advance stop lines
- Improve lighting
- Install rectangular rapid flashing beacons (RRFBs)

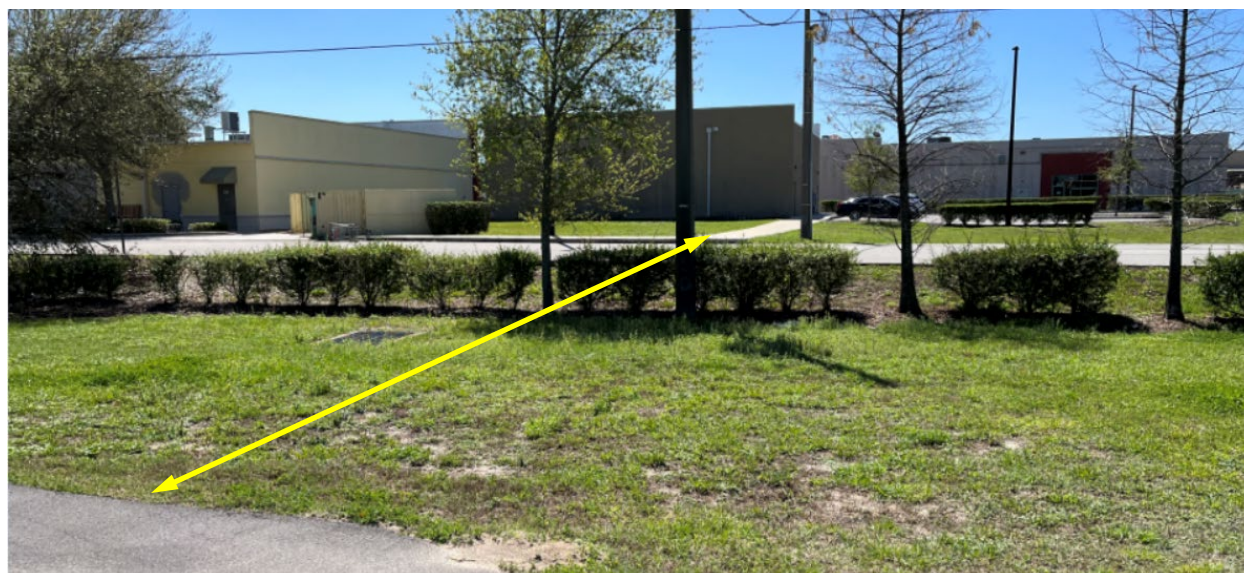
Figure 16 | Walmart Plaza Connection to Multi-Use Trail Option 2

- Option 2 would provide a connection to the back of the plaza businesses, as shown in **Figure 16**, which is closer to the existing trail crossing on Valencia College Drive (South). A small section of additional sidewalk (35 to 40 feet) would be required to provide a complete sidewalk connection to the front of the plaza from this location. **Figure 17** shows the existing sidewalk located behind the Spectrum store within the plaza. This sidewalk would need to be extended down the length of the southern side of the building to tie into the existing sidewalk at the front of the store.

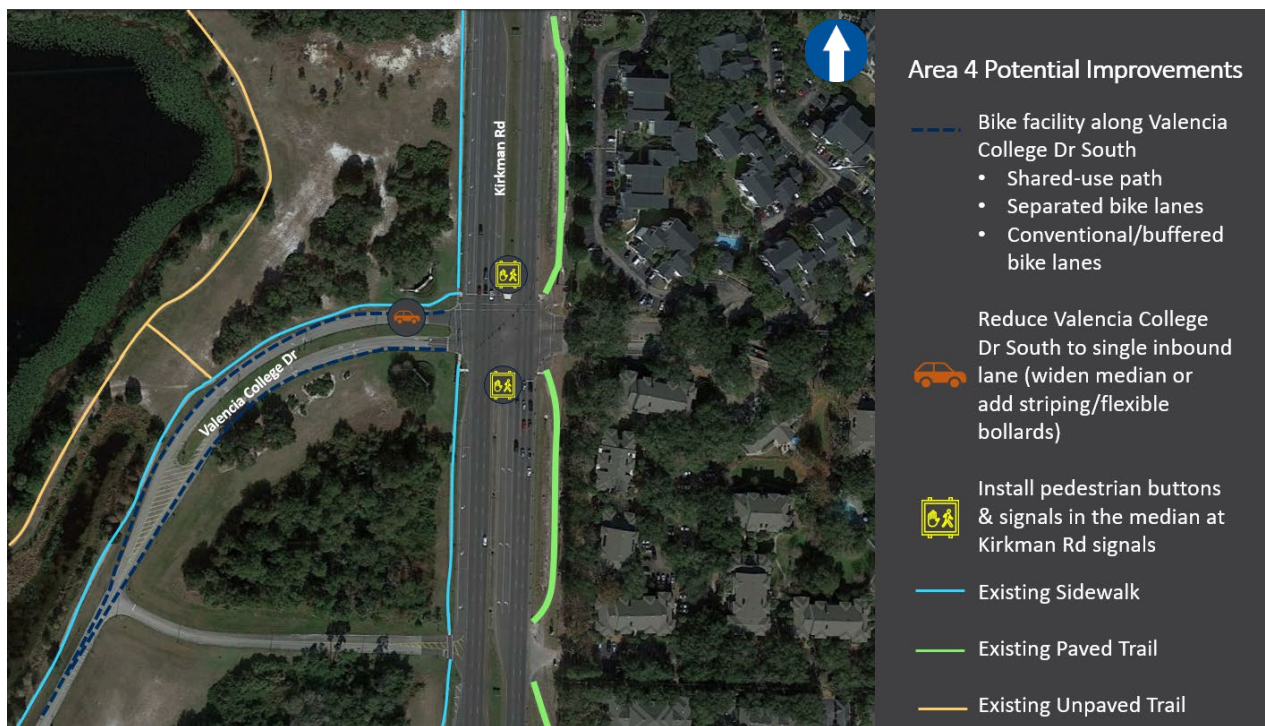
Figure 18 | Area 4 Potential Improvements

Area 4 focuses on improvements for access to campus along Valencia College Drive (South), as shown in **Figure 18**. There are three proposed treatment options, including:

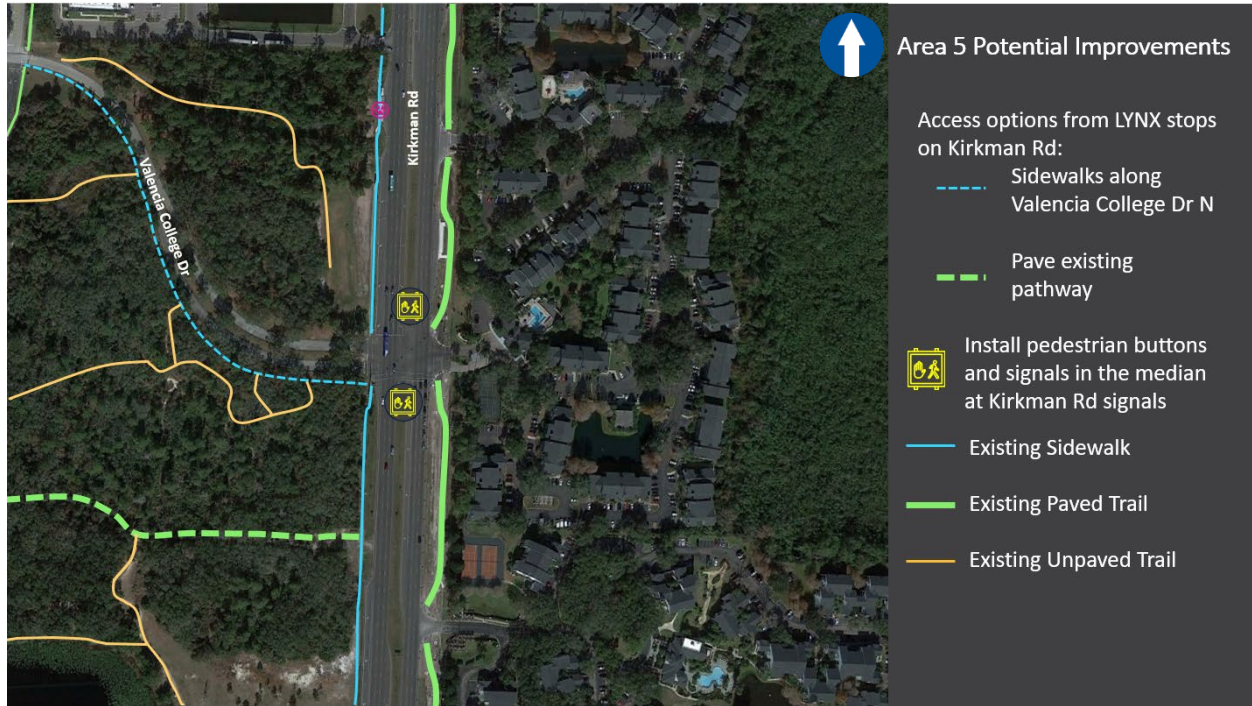
Figure 19 | Area 5 Potential Improvements

Area 5 focuses on improvements to campus access from Kirkman Road, along Valencia College Drive (North). As with Area 3 and Area 4, the installation of pedestrian buttons and signals in the median at the Kirkman Road signals is a proposed treatment. Other treatments for this location are shown in **Figure 19** and include:

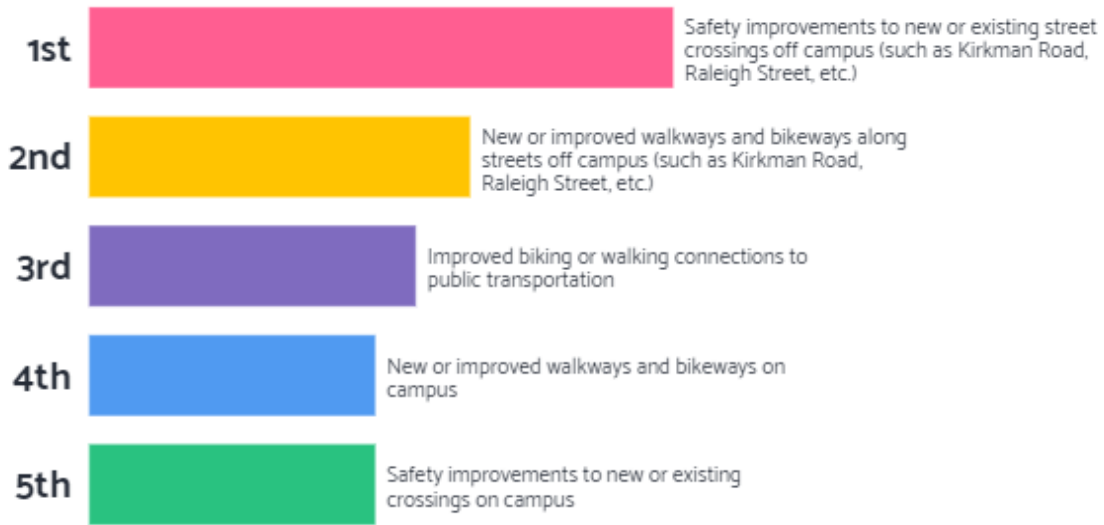
Figure 20 | Walking Audit Survey Response for Evaluation Criteria Development

To rank the potential improvements, survey results from the interactive survey from the walking audit and workshop were used to establish priorities for types and locations of improvements. The results are shown in **Figure 20**. The most important improvement type was, “Safety improvements to new or existing street crossings off campus.” Each potential improvement was evaluated on an all-or-nothing basis with point values based on the prioritization survey question results. The project team

1. Rank the most important improvement types to better support biking and walking to, from, and within the Valencia College West Campus”

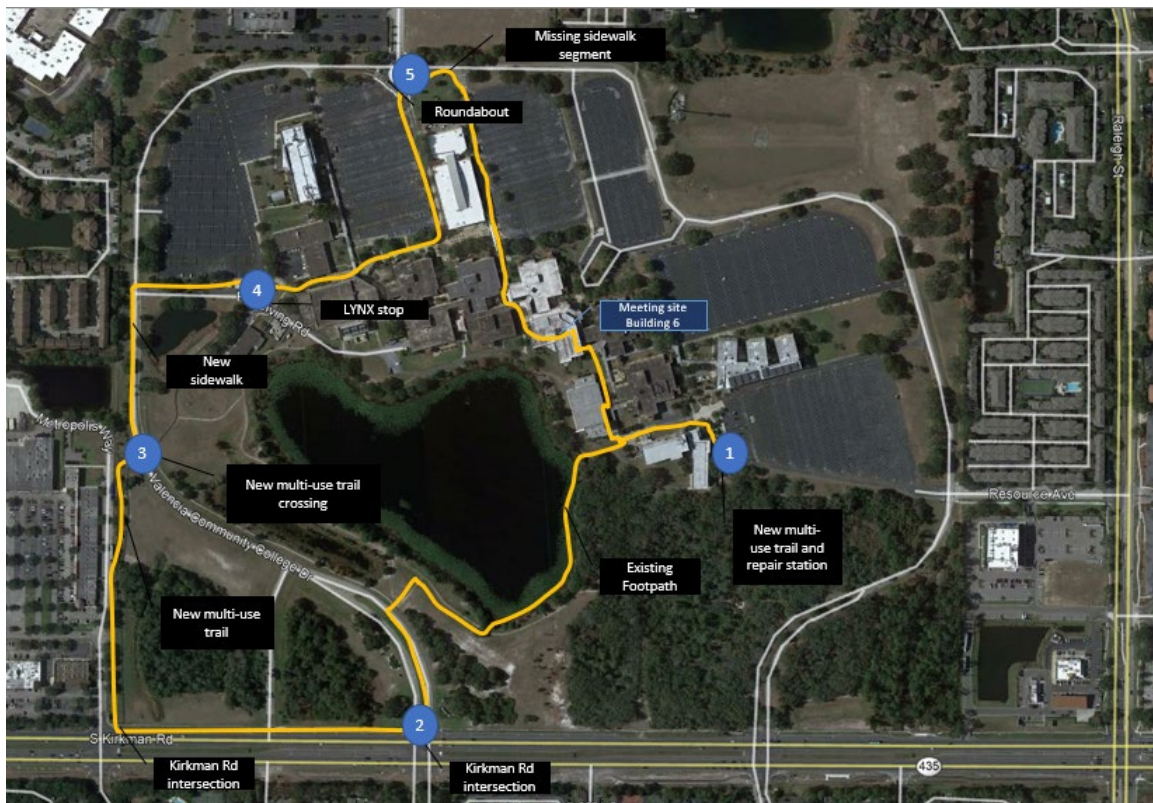
Figure 1 | Walking Audit Route

The walking audit targeted one of the busiest days for student activity for the Valencia College West Campus; however, student activity has not reached the same pre-pandemic levels and pedestrian/bicyclist flows were not reflective of regular conditions. The walking audit route included stops at five key locations around campus and the pathways/connections between them, as shown in **Figure 1**.

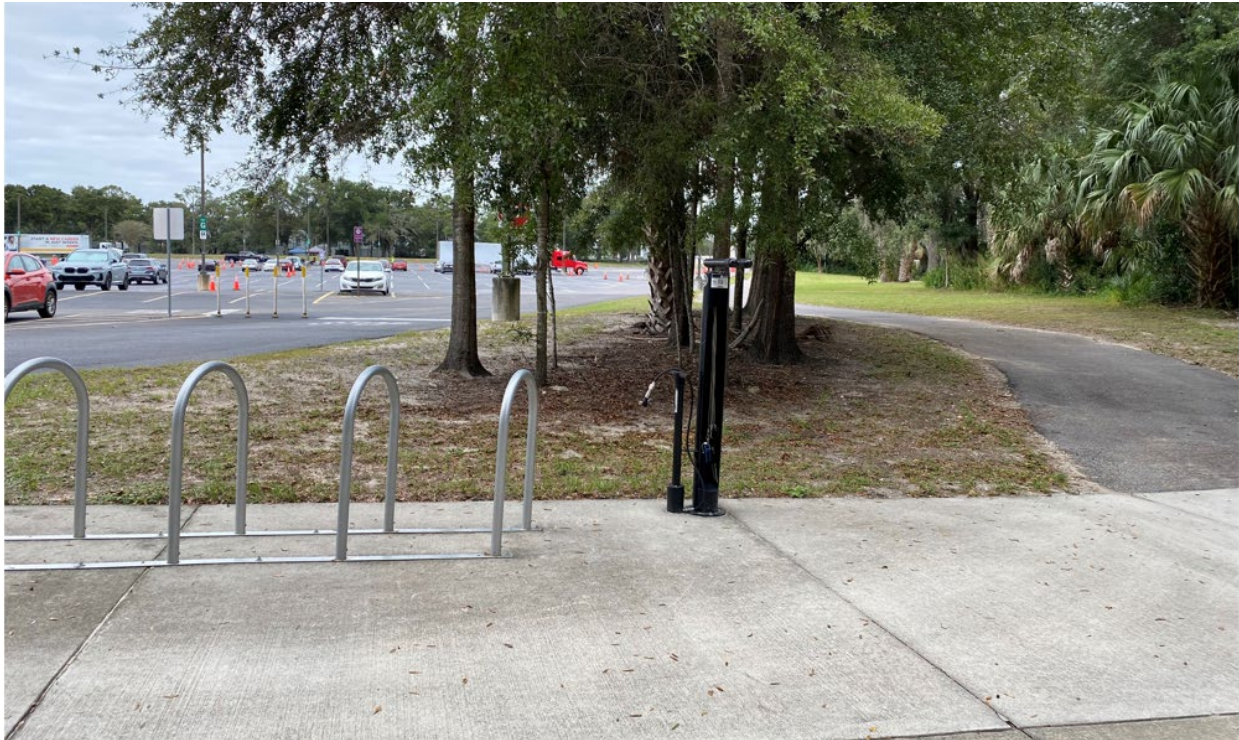
Figure 2 | Multi-Use Trail and Repair Station

1. Location 1 – Multi-Use Trail and Repair Station
 - a. The first stop was the new multi-use trail connecting the eastern edge of the core campus to Resource Avenue. Bike racks and a bike repair station are provided on the northeast side of Building 10 (see **Figure 2**).
 - b. While not a stop on the walking audit, the intersection of Resource Avenue and Raleigh Street was discussed by the participants at this location. It was noted that there may be a need for signalization at the intersection to improve safety for those crossing the intersection when walking or biking to campus from apartments on the north side of the street. It was subsequently determined that the developer of the property on the north side of this intersection is going to be installing a signal with a 50% contribution of the cost by the City.

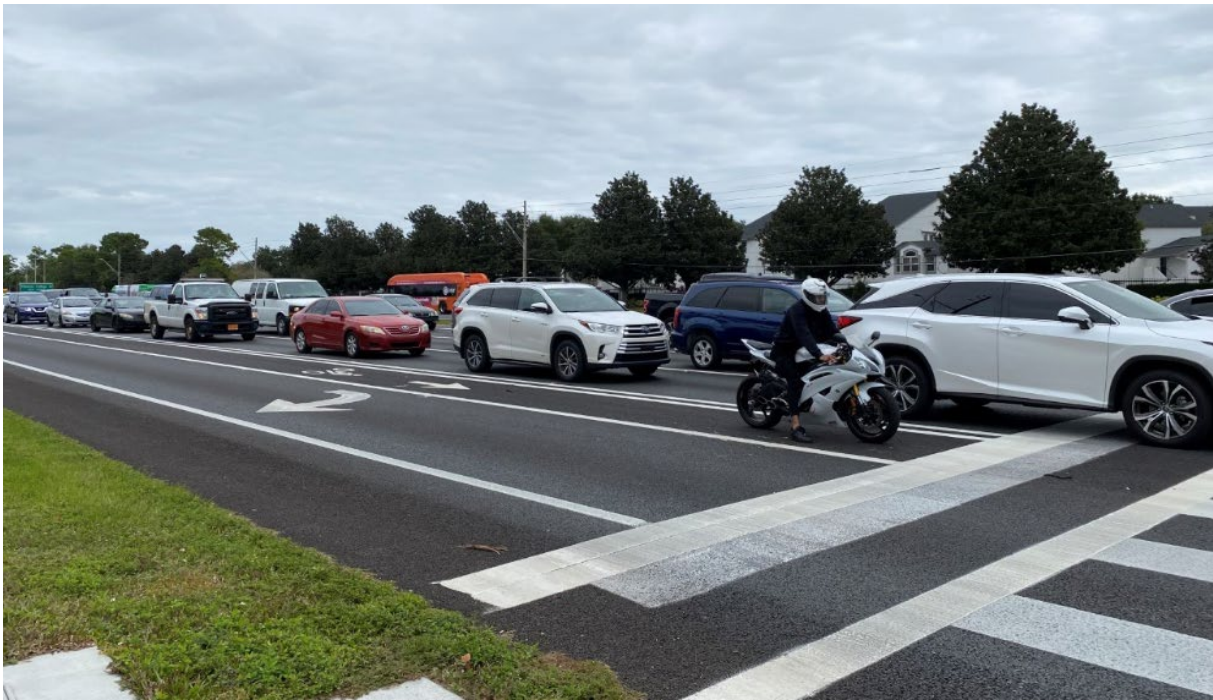
Figure 3 | Intersection of Kirkman Road and Valencia College Drive

- a. The walking audit path followed the paved trail towards Lake Pamela and turned east to follow the outlining path, paved in crushed coquina shells to the second stop at the intersection of Valencia College Drive and South Kirkman Road.
- b. While making observations at this location, it was noted that a motorcyclist was using the bike lane to pass traffic stopped at the signal (seen **Figure 3**). Several bicyclists were observed using the sidewalk rather than the buffered bike lane in the road.
- c. Median islands were being used as a refuge during pedestrian crossings.

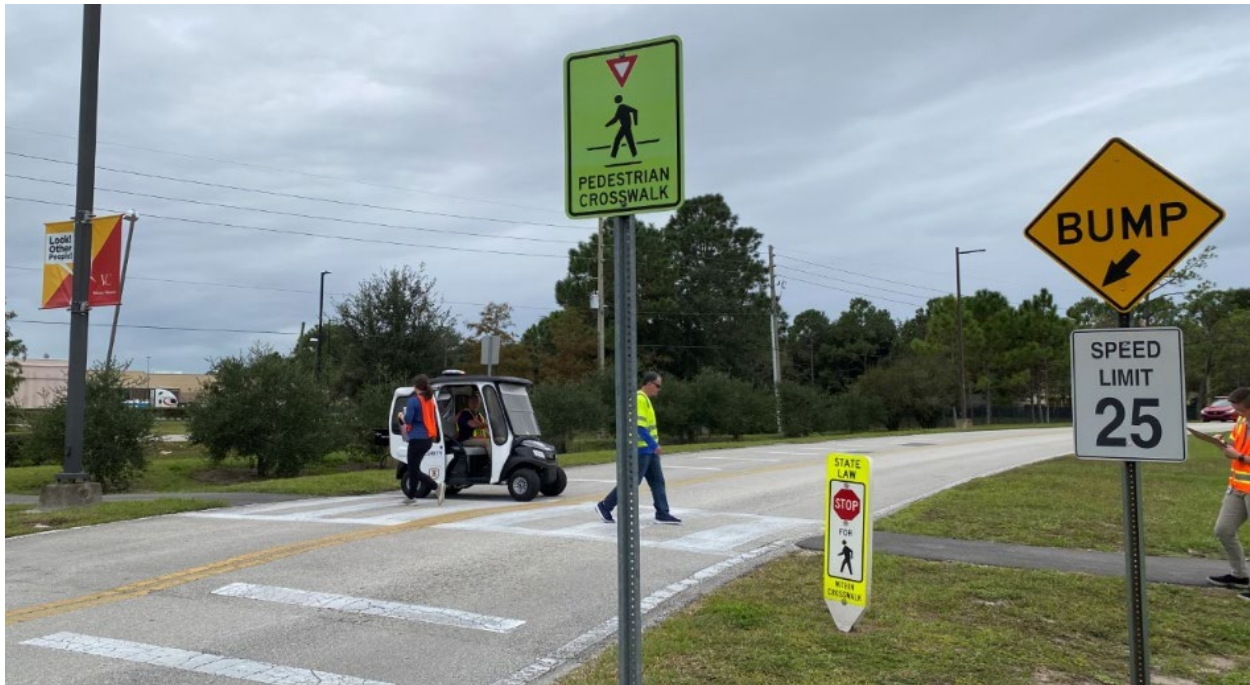
Figure 4 | Multi-Use Trail Crossing

- a. From the second stop the audit path followed the sidewalk south along Kirkman Road to the new multi-use trail that follows the property line into campus westward. The third stop location was the crosswalk where the new multi-use trail crosses over Valencia College Drive.
- b. At this location, there are several pedestrian crossing warning signs and a raised pedestrian crossing (See **Figure 4**). However, non-standard pedestrian crossing signs are being used. The Manual on Uniform Traffic Control Devices for Streets and Highways (MUTCD) defines the standards used nationwide to install and maintain traffic

control devices on all public streets, highways, bikeways, and private roads open to public travel. Additionally, the existing signs have contradictory messaging with one indicate stopping for pedestrians and another indicate yielding conditions.

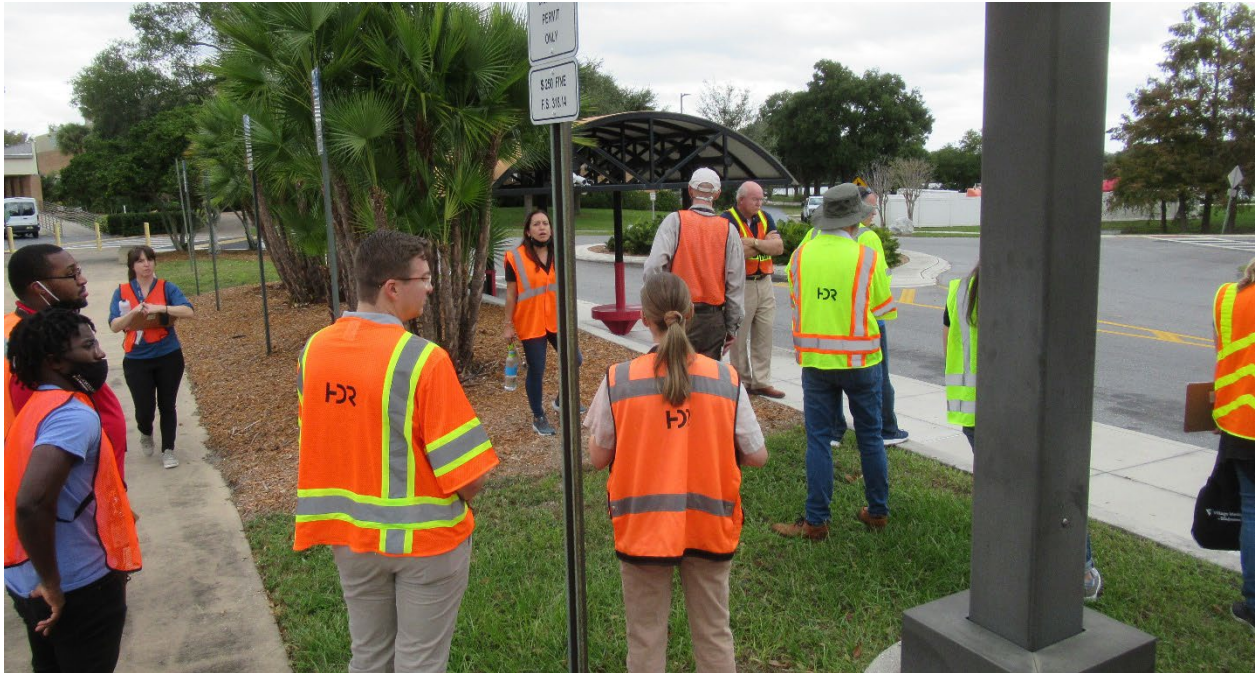
Figure 5 | LYNX Bus Stop

- a. The route continued westward on the sidewalk along Valencia College Drive turning north along Receiving Road to the LYNX bus stop on campus.
- b. This LYNX stop provides two sheltered waiting areas with seating and video surveillance (See **Figure 5**); however, there is no provision of bike racks. Implementing bike racks would improve access to transit by providing opportunities for LYNX passengers to leave their bike parked while riding the bus – an important consideration if a bus arrives and its racks are already full.
- c. It was mentioned by students that busses, especially articulated busses, often encroached on the sidewalk when making the U-turn to reach the passenger loading/unloading area.

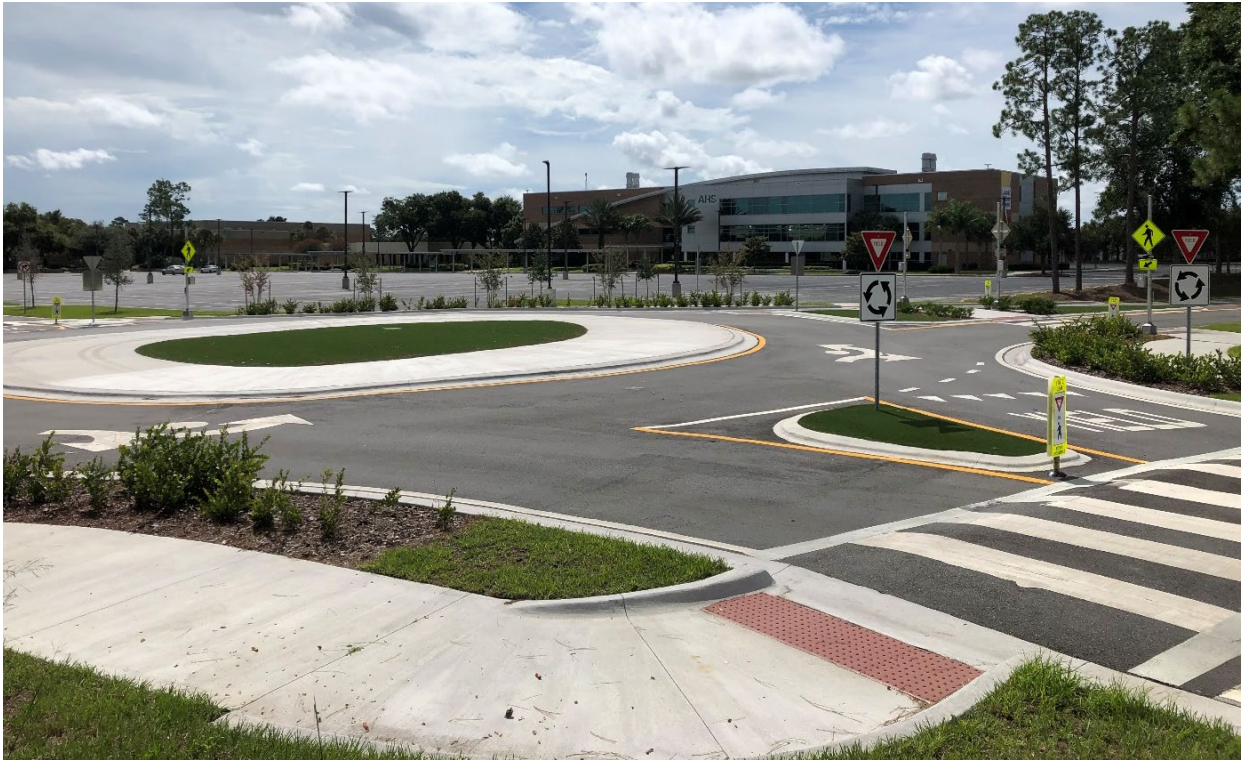
Figure 6 | Valencia College Drive Roundabout

- a. The final leg of the walking audit included the newly installed roundabout at Valencia College Drive and Metrocenter Boulevard (See **Figure 6**).
- b. Campus security and operations staff mentioned that the installment of the roundabout has improved traffic operations and safety at this intersection compared to the previous all-way stop control.
- c. Several students and faculty members also mentioned that there is no convenient pedestrian access to the nearby Valencia Headquarters Building (located on Park Center Drive).

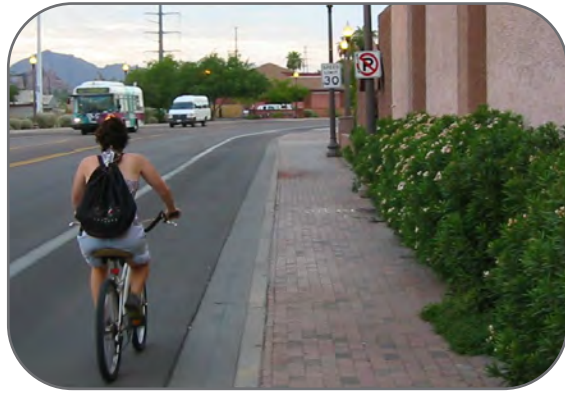
Bike Lane

Dedicated space for bicyclists separate from vehicles

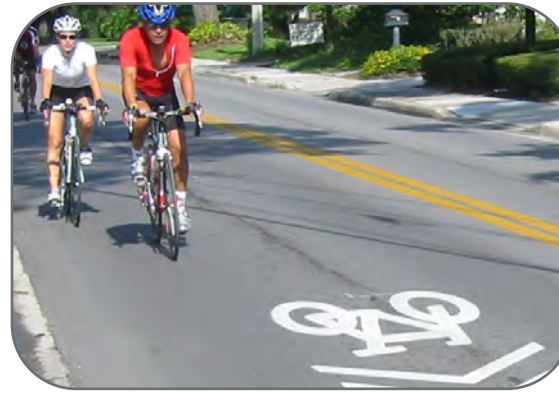
Shared Lane Markings

Guidance to bicyclists and motorists & encourage safer passing practices

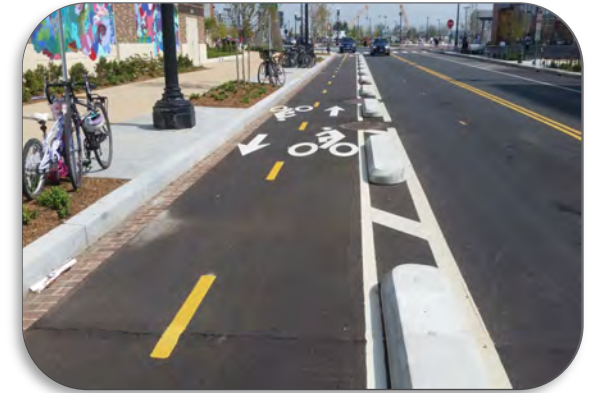
Protected Bike Lanes

Separated bike lanes protected with a barrier from free-flowing traffic

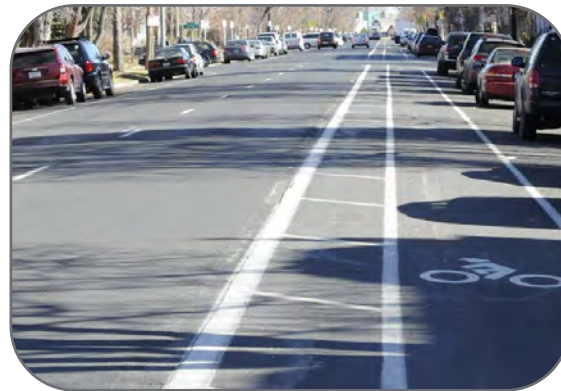
Buffered Bike Lane

Increased separation from vehicular traffic

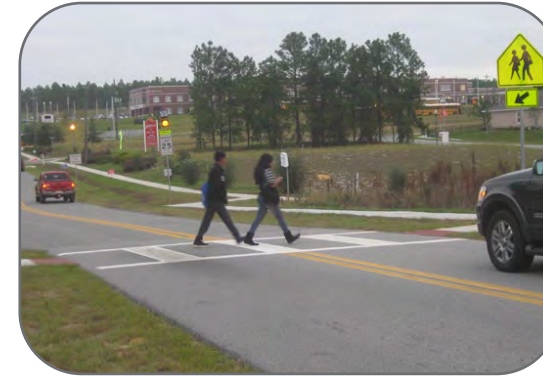
High-Visibility Signs & Markings

Increase driver awareness of the pedestrian crossing

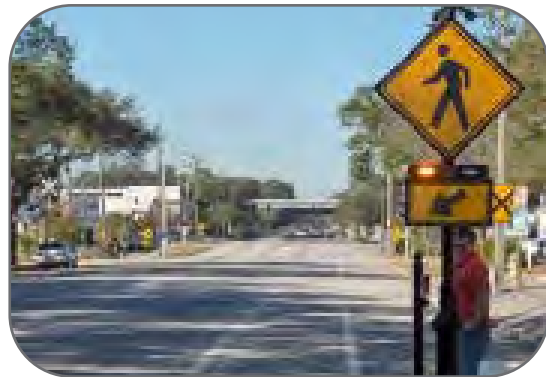
RRFB

Increased driver yielding compliance

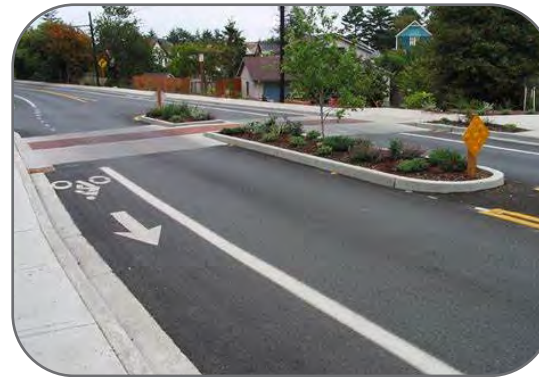
Median Island

Allow crossing in two stages, focusing on each direction of traffic separately

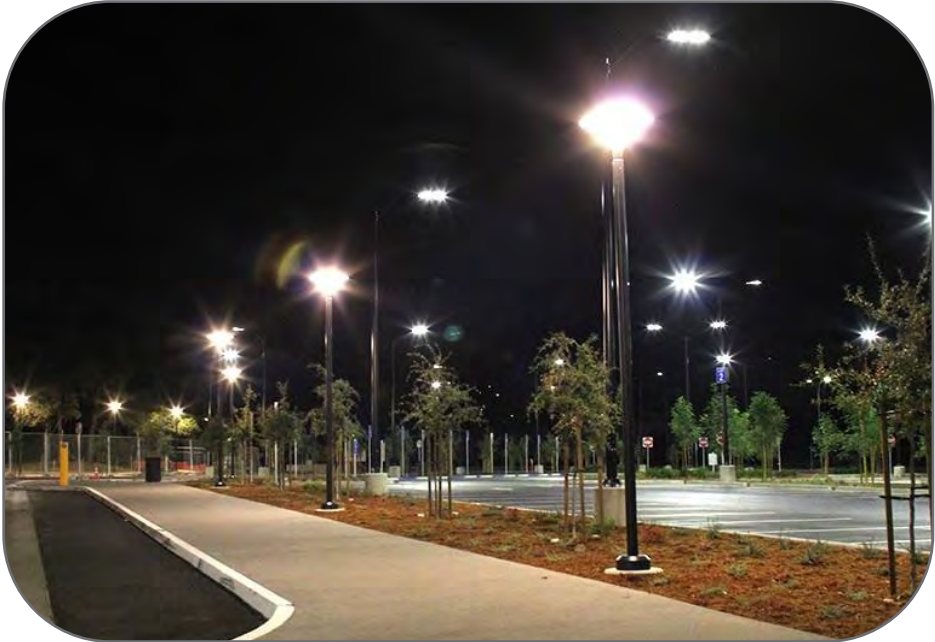
Lighting

Ped-scale lighting and intersection street lighting
Increases visibility of pedestrians and bicyclists

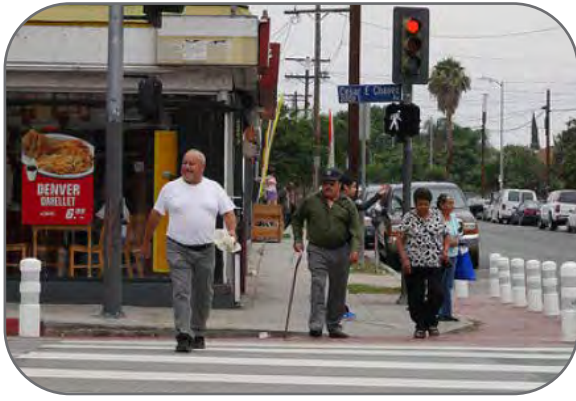
Leading Pedestrian Intervals

Head start at signal to reduce conflicts between turning vehicles and pedestrians/bicyclists

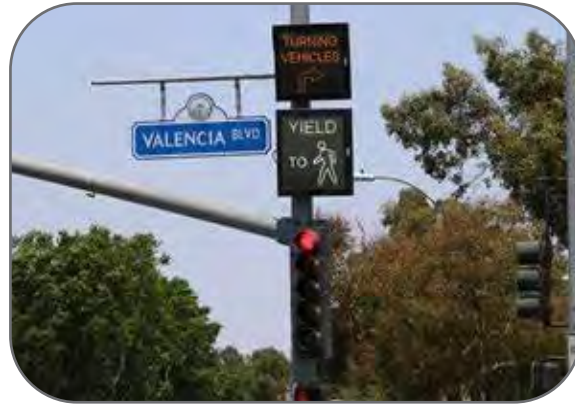
Yield to Peds Blank-Out Sign

Increase awareness of crossing pedestrians at intersections

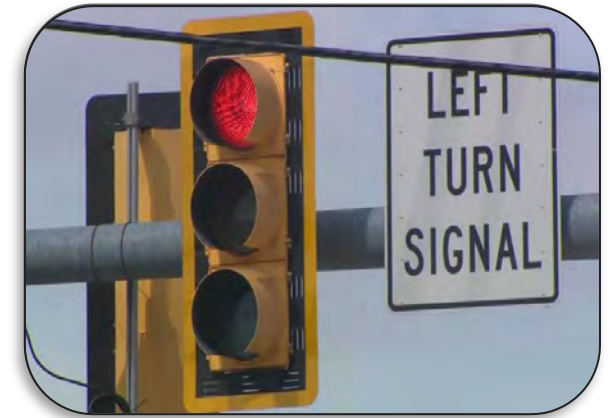
Exclusive Left-Turn Phase

Eliminates conflicts between left turning vehicles and pedestrians

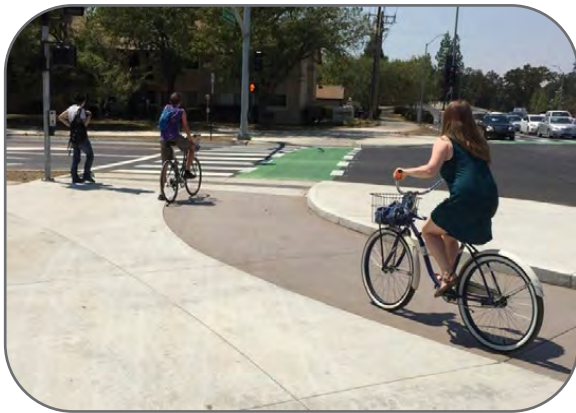
Protected Intersections

Separated space for ped/bikes leading up to and through an intersection

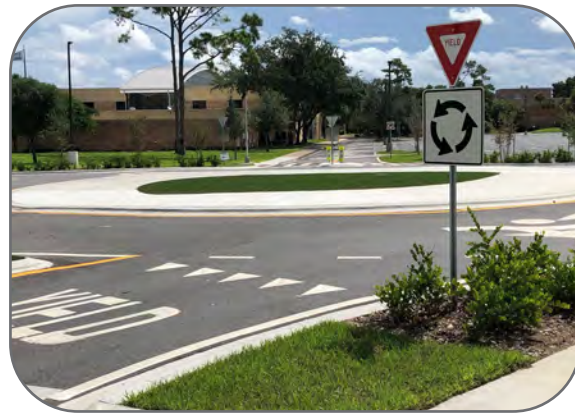
Roundabout

Slows vehicles, reduces conflicts, & reduces crash frequency & severity

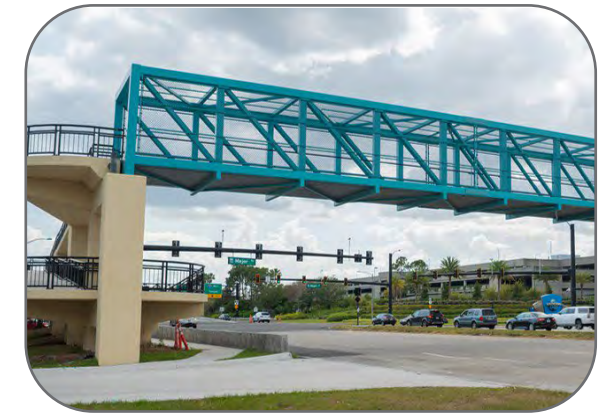
Overpass

Eliminates conflicts with vehicles at street level
